COMPLIANCE INSPECTION CHECKLIST HAZARDOUS WASTE COVER PAGE

RCRA Compliance Evaluation Inspection Summary

RINGSIDE MFG

Inspection Dates: April 7 and 8, 2009

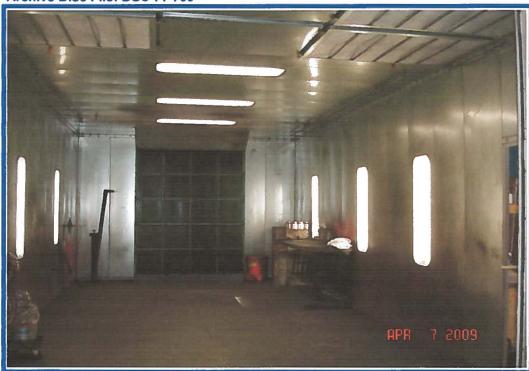
Picture No.:
 1

View of the facility's paint booth located in the southeast corner of the manufacturing area.

Metal boxing rings, cages, and speed bag platforms and wood speed bag platforms are manufactured at the site. One paint booth is located in the southeast corner of the manufacturing area (Photo 1). Paint booth filters removed and replaced on an as needed basis are shipped off-site as D007, D008, F003, F005 hazardous waste (Photo 2).

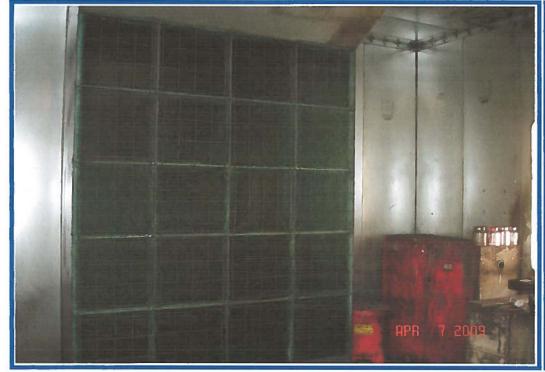
Picture No.: 2

Close-up of the paint booth's filters.

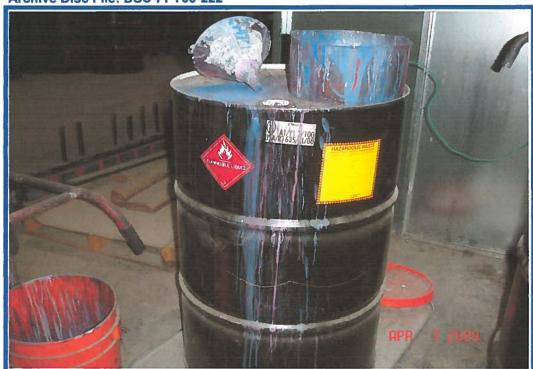
Picture No.:
 3

Satellite accumulation container of liquid waste generated from cleaning the facility's paint guns and pot.

Liquid paint waste (paint and lacquer thinner) generated from cleaning the facility's two working guns and one paint pot is accumulated in a 55-gallon closed head, metal satellite accumulation container located immediately adjacent to the east wall of the paint booth and shipped off-site as D001, D035, F003, F005 hazardous waste (Photo 3).

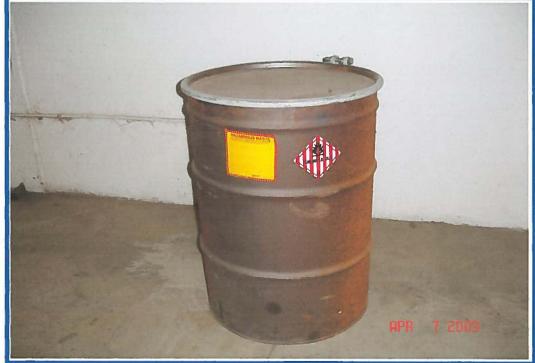
Picture No.:
 4

Storage accumulation container of paint waste solids generated at the facility.

gallon open head, metal containers. At the time of the inspection, one full storage accumulation container of solid paint waste was located in the facility's designated hazardous waste storage area (Photo 4) and one partial satellite accumulation container of solid paint waste was located immediately adjacent to the east wall of the paint booth (Photo 5).

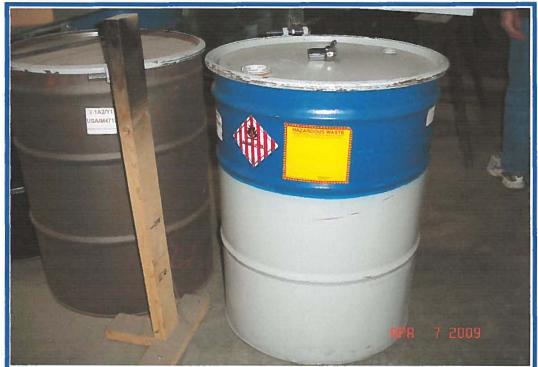
Picture No.:
 5

Satellite accumulation container of paint waste solids generated at the facility.

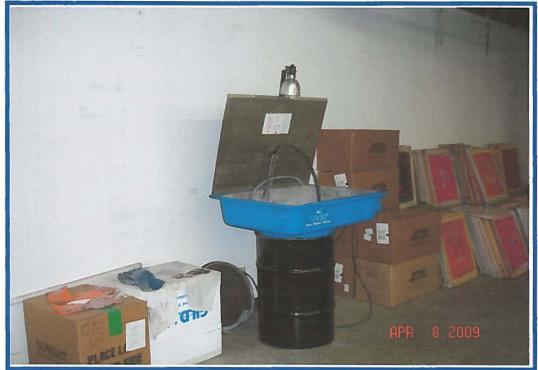
Picture No.:
 6

View of the parts washer used in the facility screen printing area. Solvent generated from use of the parts washer is enrolled in Crystal Clean's Continued Use Program.

Mineral spirits solvent is used in a parts washer to clean wood squeegees used in the screen printing area (Photo 6). Approximately 15 gallons of solvent is removed from the parts washer every four months and managed through Crystal Clean's Continued Use Program. A copy of the facility's Generation Certification form for enrollment in the Continued Use Program is included in this report as Attachment 1.

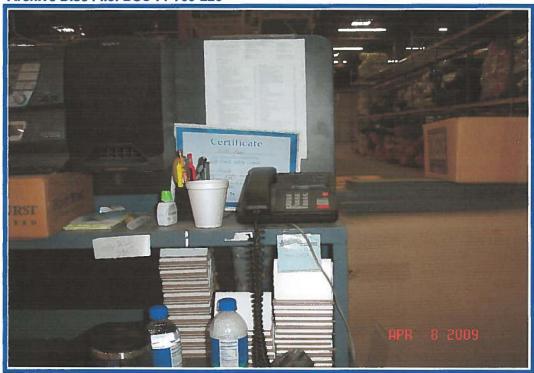
Picture No.:
 7

K.A.R. 28-31-4(h)(7). During the inspection, I observed the area surrounding the telephone located closest to the facility's designated hazardous waste storage and paint booth areas (Photo 7). None of the required information was posted next to the telephone. When I asked Mr. VanNote and Mr. Munro if the required emergency information was posted next to any other telephone located at the site, they replied no.

None of the required emergency response information was posted next to the phone accessible in an emergency.

<u>Violation 4</u>. Failure to post emergency information next to at least one telephone accessible, with little or no delay, in an emergency in violation of
